## AVIAN ELECTROCUTIONS ON INCORRECTLY RETROFITTED POWER POLES

JAMES F. DWYER,<sup>1</sup> RICHARD E. HARNESS, AND DUNCAN ECCLESTON  
*EDM International Inc., Fort Collins, CO 80525 U.S.A.*

**ABSTRACT.**—Avian electrocutions on power poles (hereafter, poles) are a global conservation concern, particularly for large-bodied species like Golden Eagles (*Aquila chrysaetos*). Retrofitting poles through increasing clearances (separation) between components, adding insulation to components, or adding redirection materials like perch discouragers reduces risk, but electrocutions may occur even on retrofitted poles. We evaluated 52 retrofitted poles where 56 birds, including 17 Golden Eagles, were electrocuted after retrofitting. We used burns on pole equipment and carcasses to identify precise pole-top locations where electrocutions occurred, and we identified three categories of retrofitting errors: product design, mitigation plan, and application. Product design errors ( $n=9$  poles, 6 Golden Eagles) occurred when products did not sufficiently cover energized equipment. Mitigation plan errors ( $n=30$  poles, 6 Golden Eagles) occurred when retrofitting plans did not include coverage o

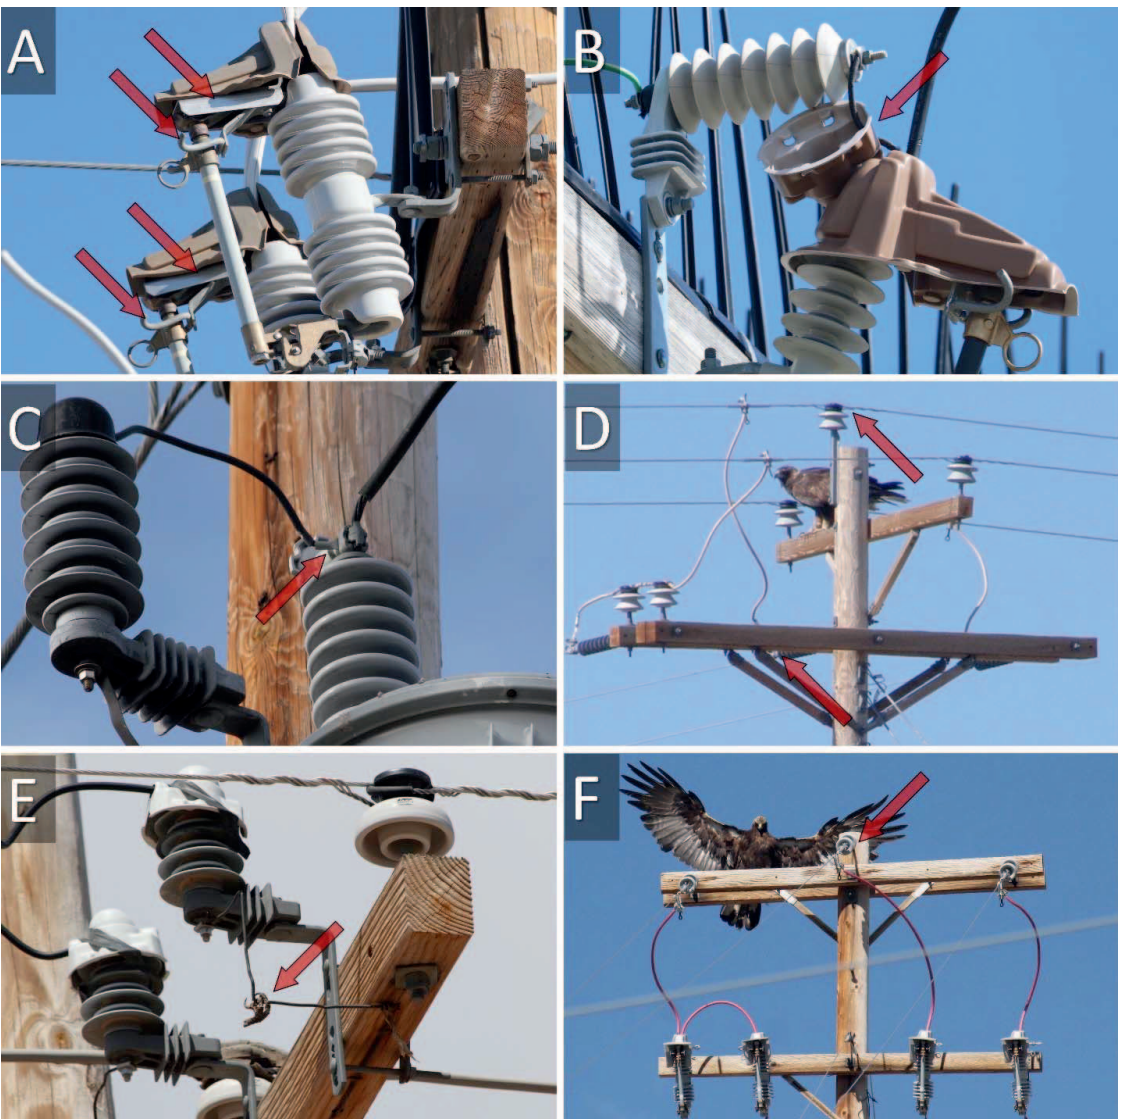
Mitigation plan errors were most frequent, followed by application errors, and product design errors. Components involved in electrocutions differed by error type (Table 3), but all resulted from inadequate insulation. Product design errors occurred when covers did not fully cover all energized parts of the tops of cutouts (Fig. 4A), and when covers fell off (Fig. 4B, C). Among mitigation plan errors, the most common errors were failures to specify covers for all energized equipment and all energized jumpers on poles. We identified omissions of one or more conductor covers and deadend covers (Fig. 4D, E, F), cutout covers and arrester covers (Fig. 5A), bushing covers (Fig. 5B), and jumper covers (Fig. 5C). Mitigation plan errors also occurred where vertical clearances were not adequately considered (Fig. 5D). Application errors consistently resulted from gaps in jumper coverage (Fig. 5E, F).

Figure 4. Arrows indicate retrofitting errors. (A) Product design error: covers installed on cutouts but energized tops remain exposed. (B) Product design error: arrester cap dislodged and locking horns exposed. (C) Product design error: arrester and jumpers covered, but bushing cover dislodged. (D) Mitigation plan error: jumpers covered, but conductor cover (upper arrow) and deadend cover (lower arrow) absent. (E) Mitigation plan error: the foot of a Chihuahuan Raven on an arrester ground resulting from routing the uninsulated ground wire below the exposed primary conductor. (F) Mitigation plan error: all energized equipment covered, except deadend cover absent.

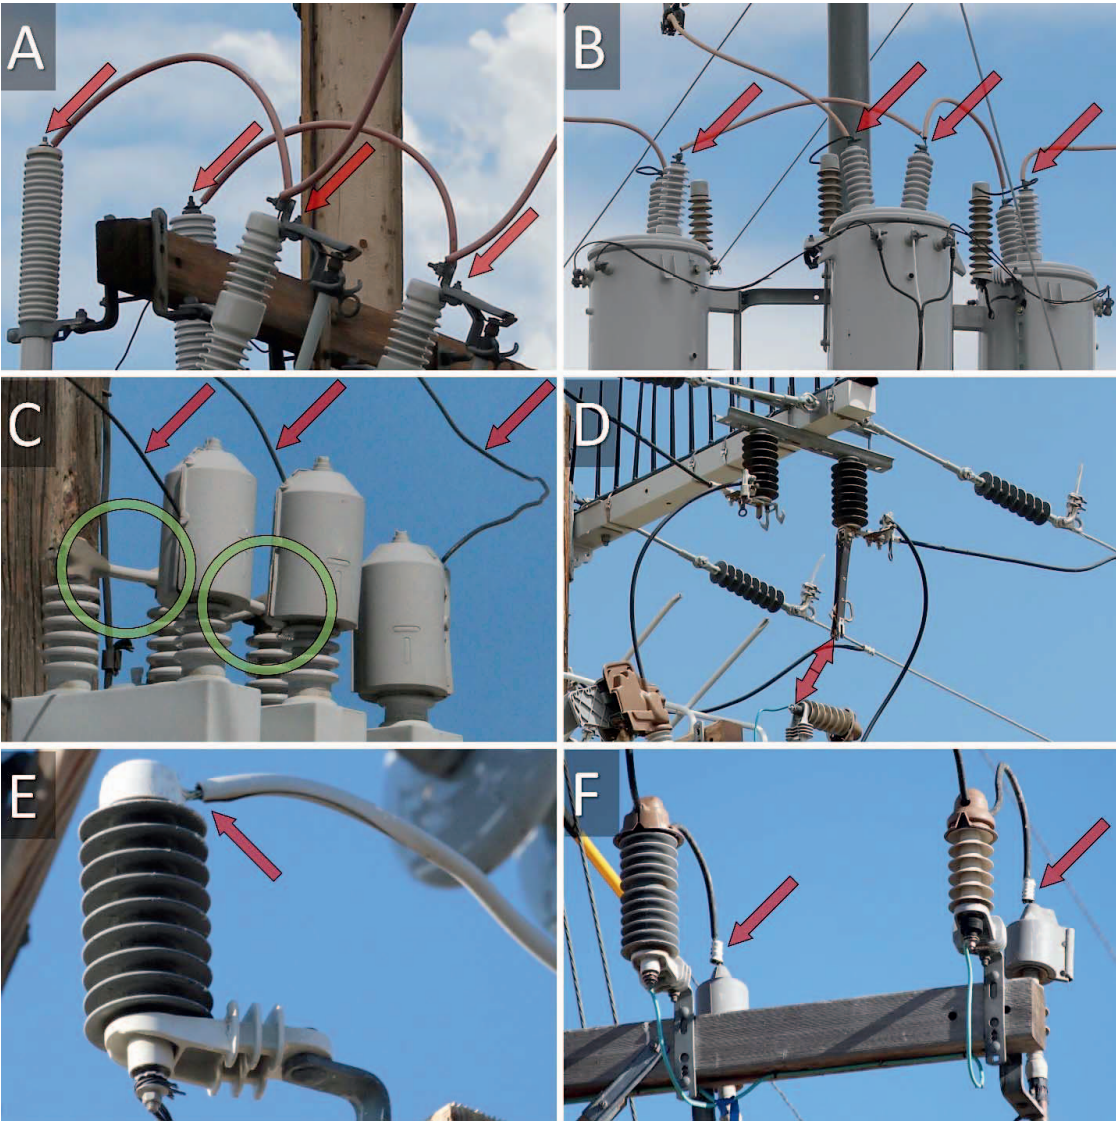
Figure 5. Arrows indicate retrofitting errors. (A) Mitigation plan error: jumpers covered, but arrester covers (left arrows) and cutout covers (right arrows) absent. (B) Mitigation plan error: jumpers and arresters covered, but bushing covers not installed. (C) Mitigation plan error: bushings and jumpers between bushings (circles) covered, but jumpers exposed above (arrows). (D) Mitigation plan error: insufficient clearance between open switch above and grounded arrester connection below. Redirection materials on the upper crossarm may also push birds into perching near energized components on the lower crossarm. (E) Application error: jumper and arrester covered, but a gap in jumper coverage exists between retrofitting products. (F) Application error: all equipment covered, but gaps in coverage where jumpers connect.

Mitigation plan errors were most frequent in our dataset. These errors may indicate lack of understanding of electrocution risk by personnel planning retrofitting if some potential points of contact are not recognized, and thus not included in the retrofitting plan. Mitigation plan errors may also indicate a lack of knowledge of, or access to, the full range of retrofitting products on the market. These errors are preventable in part through thoroughly understanding risks associated with various contact points and retrofitting errors, and in part through improved training. The APLIC regularly produces training manuals and hosts training-oriented meetings that can help interested personnel keep informed of new retrofitting products and techniques (APLIC 2006).

Application errors were the second-most common error type ( $n = 13$  poles, 5 Golden Eagles). Application errors were unexpected given that personnel installing retrofitting products are well-trained to be aware of potential points of electrical contact for their own safety. Correcting application errors may be a simple matter of conveying more clearly to installation crews that they must completely cover all energized components of equipment identified for insulation. For example, when jumpers are insulated, the insulation should be inserted inside insulating covers on equipment (Fig. 6E). Regular training regarding application materials, techniques, and errors observed would help in this regard.
