Relationships Between Landsliding and Land Use in the Likhu Khola Drainage Basin, Middle Hills, Nepal

Source: Mountain Research and Development, 22(1) : 48-55

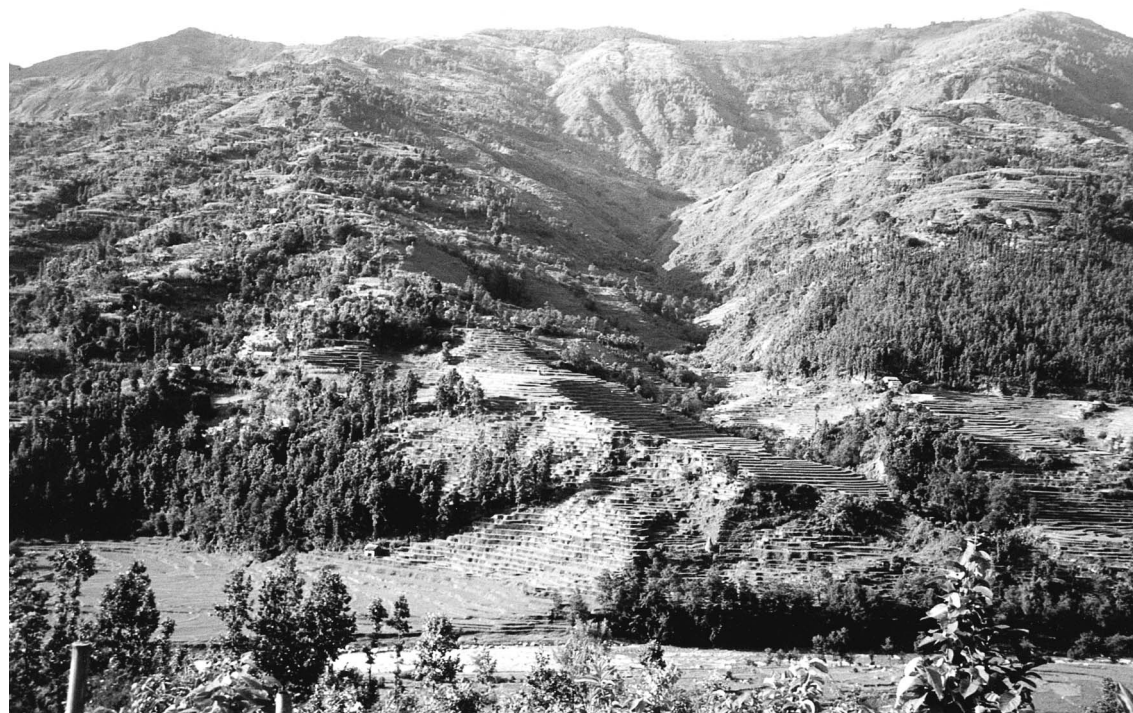
FIGURE 3 General view of the Dee subcatchment of the Likhu Khola (visible in the foreground), with *khet* terraces on the lower slopes and patches of woodland and *bari* terraces on the higher slopes. A few landslide scars are visible. (Photo by John Gerrard)
