AVIAN ELECTROCUTIONS IN WESTERN RAJASTHAN, INDIA

RICHARD E. HARNESS EDM International, Inc., Fort Collins, CO 80525 U.S.A.

ABSTRACT.—Avian electrocutions are regularly documented worldwide. Electrocutions are thought to affect avian populations in Asia, but regional research has not been widely disseminated. In this study, we sought to identify whether power lines in rural India were involved in avian electrocutions and, if so, to identify atrisk species and problematic configurations, and to develop a predictive model. To collect data, we visited power poles to search for avian carcasses. We recorded six variables at each pole: line voltage, insulator configuration, conductor separation, jumper count, surrounding habitat, and presence of an avian carcass. We used multivariate logistic regression to model the probability that an avian carcass was found. We surveyed 15 line segments supported by 675 poles, and found 162 carcasses. We found carcasses of five raptor species, including Eurasian Kestrel (n = 5; Falco tinnunculus) and White-eyed Buzzard (n = 4; Butastur teesa), though passerine carcasses were more numerous. All modeled variables contributed to the probability of findin

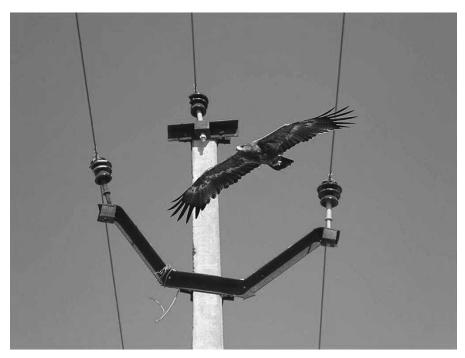
Figure 1. Typical 11-kV concrete pole with a grounded metal cross-arm. A Steppe Eagle (*Aquila nipalensis*), a common raptor in Rajasthan, India, with a wingspan of 165–190 cm, provides a reference for relative size.
